NEW YORK BICYCLING COALITION
IMPROVING BICYCLING AND PEDESTRIAN SAFETY

THE PROJECT PROPOSAL: CASE STUDIES

Individual Case Studies

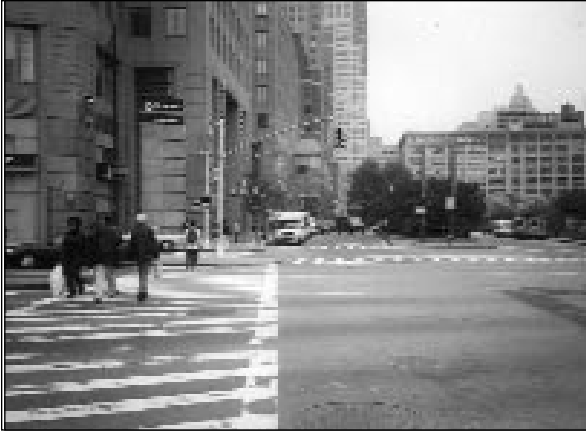
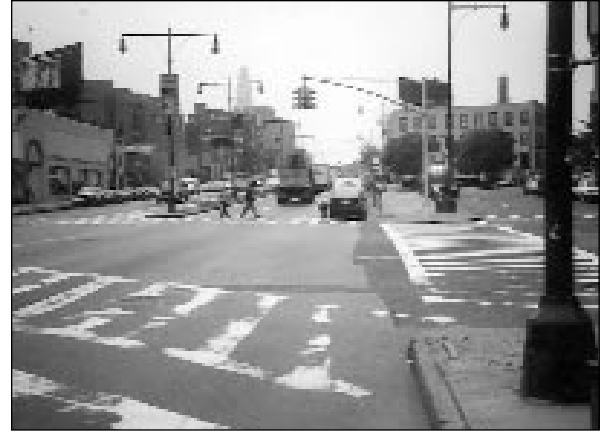
This is an exceedingly busy stretch of road with the Flatbush Ave./Myrtle Ave. and Flatbush Ave./Tillary St. intersections congested with vehicular and pedestrian traffic. Flatbush Ave. is a major arterial with 8 lanes, 5 northbound (2 reserved for left turns) and 3 southbound, with a 5 ft curbed median.

Tillary St. is a major arterial with 6 lanes and a curbed median and Myrtle Ave. is an arterial with 4 lanes with a wide landscaped median on the west side. The Flatbush Ave./Myrtle Ave. intersection is a five-legged skewed intersection with Gold Street, a one-way low volume road heading northeast from the intersection. The Flatbush Ave./Tillary St. intersection is crossed by Duffield Avenue, a short diagonal road in the southeast corner of the intersection going from Flatbush Ave. to Tillary St. Low volume intersecting roads, Johnson Street and Tech Place, are across from each other midway between the two main intersections. Pedestrian signals are provided. There are no specific provisions for bicyclists. From September 1994 to August 1999, 799 crashes, including 9 bicyclist and 36 pedestrian crashes were reported over this 924 ft stretch of road.

- Institutional and commercial facilities characterize this busy urban intersection with heavy vehicular and pedestrian traffic.
- Pedestrian errors include jaywalking and crossing against the signal.
- There are no curb ramps at intersections.
- Motorists do not pay attention to pedestrians or yield right of way.

- There is no shoulder on the road, nor any other bicyclist-specific facility.
- Extensive parallel parking of motor vehicles produces possible conflicts with car doors, etc.
- Road surface is irregular with drains and grates in bicyclists' path.
- Utility covers are not flush with road surface.
- Turning radii are large, allowing cars to corner at high rates of speed.
- There is heavy motor vehicle traffic.

- Plethora of commercial, regulatory and warning signage adds the challenge of safely negotiating this stretch of roadway.
- Motorists not paying attention or yielding right of way to pedestrians and bicyclists have resulted in numerous crashes.

- Increase signal time for both Myrtle Ave and Tillary St. will allow pedestrians to cross Flatbush Avenue along with lead timing for pedestrians and bicyclists where appropriate.

- Install "Trailblazer" signs routing bicyclist around Flatbush to avoid section entirely.
- Install raised/textured "ladder style" crosswalks with reflectorized markings across all four legs of Flatbush Ave./Myrtle Ave. and Flatbush Ave./Tillary St. intersections using high quality materials.

- Install enforceable signage for pedestrians on each corner of both intersections, as follows: WAIT FOR WALK SIGNAL.
- At the corners of the intersection with Johnson Street and Tech Place, install enforceable signage for pedestrians as follows: CROSS ONLY AT CROSSWALKS.

- Install NO RIGHT TURN ON RED signage. Since NYC law already prohibits right on red turns, the sign can have "anywhere in NY City" underneath in smaller letters.

- Determine if a crosswalk is warranted at the intersection of Flatbush Avenue with Johnson Street and Tech Place.
- Install pedestrian signals at the corners of Flatbush Avenue/Myrtle Ave. and Flatbush Avenue/Tillary St.
- Install bicycle lanes and intersection controls.

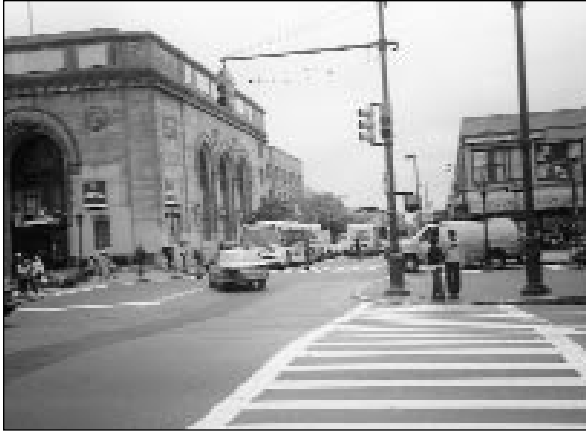
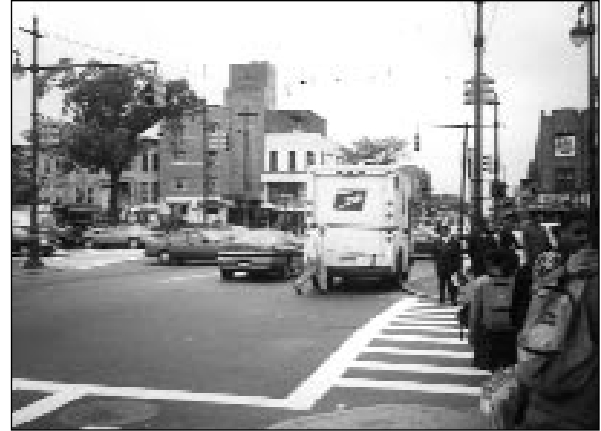
The Utica Avenue intersection with Eastern Parkway, located in the Crown Heights, north central section of Brooklyn (Kings County), is a mix of intense commercial use on Utica and high rise apartments on Eastern. Utica Avenue carries a high volume mix of cars, trucks, transit busses and school busses. No commercial traffic is allowed on Eastern Parkway, which is striped for three lanes eastbound and two lanes westbound separated by a striped median. A sidewalk with benches is located between the service roads and Eastern Parkway. A bicycle lane is provided along the sidewalk between the eastbound service road and Eastern Parkway. Traffic counts were unavailable. From September 1994 to August 1999, 489 crashes, including 68 pedestrian and 6 bicyclist crashes, were reported. Though well-thought-out traffic control devices currently exist at this intersection, additional safety measures are warranted to reduce the number of reported crashes.

- This is an extremely busy intersection with heavy traffic volumes and surging pedestrian flows, exacerbated by boarding and alighting subway passengers and multiple roadway crossings to traverse.
- Pedestrian signals are in place for pedestrians crossing Eastern Parkway only. None are available to guide and control pedestrian flow across Utica Avenue or the service roads.
- Pedestrians were observed jay walking across Eastern, Utica and the service roads, increasing the potential for serious pedestrian crashes at this location.
- Eleven of the reported 68 pedestrian crashes involved pedestrians crossing against the signal, which is dangerous, but not uncommon, where pedestrian volumes are high.

- Intensely busy intersection, heavy vehicular and pedestrian traffic.
- Pedestrian conflict area in vicinity of bicycle path and subway station entrance.
- Bicycle path users experience high risk crossing Utica Avenue.

- Utica avenue is a heavily used north-south commercial corridor with a mixture of autos and trucks (some making on-street deliveries), transit busses, school busses and crowds of pedestrians.
- Commercial vehicles are prohibited on Eastern Parkway; auto traffic is heavy but generally smooth flowing.
- Jay walking pedestrians require motorists to be especially alert.
- Nearly chronic congestion exists at the intersection of Utica Avenue and Eastern Parkway. "Blocking the box" traffic conditions are frequent.

- Add two new signs, appropriately placed, to reduce jay walking and crossing against the signal, that read: DO NOT JAY WALK: USE CROSSWALKS and WAIT FOR WALK SIGNAL

- Add pedestrian signals at each of the four outer corners of the intersection of Utica Avenue and the eastbound and westbound service roads to guide and control pedestrian movements (primarily across Utica Avenue).
- Surface treatments, such as color pigmented pavement, will better indicate the bicycle path crossings at major Eastern Parkway intersections, including Utica Ave., and will alert motorists to the upcoming crossings.
- Install bicycle lanes and intersection controls.

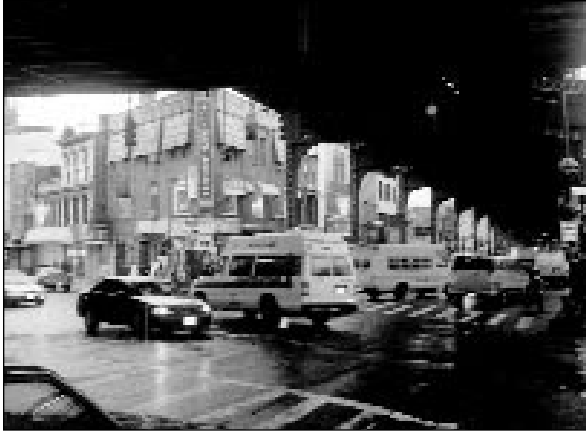
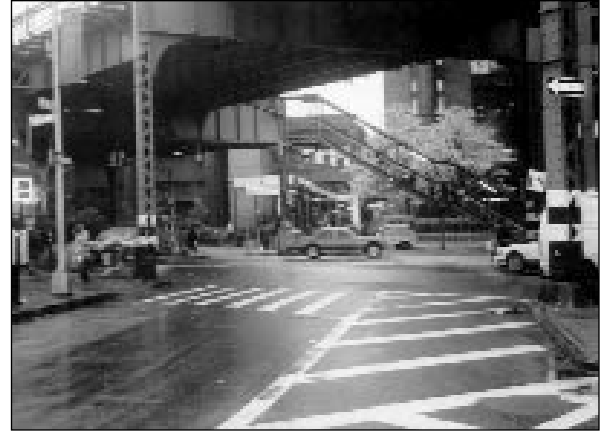
The Broadway at Flushing intersection in King's County is a five-legged skewed intersection under an elevated subway line with intense pedestrian activity. All five legs of the intersection are considered major arterials. Pedestrian signals are provided. There are no provisions for bicyclists. In the past five years, 122 accidents, including 6 bicyclist and 21 pedestrian accidents were reported.

- Subway entrances, bus stops and intense commercial retail shopping characterize this busy urban intersection with heavy vehicular and pedestrian traffic
- Pedestrians are waiting in the street for the walk signal or a gap in traffic to jay walk across the street
- Jaywalking, walking along the roadway and crossing against the signal
- Lack of curb ramps at intersections
- Obstructions in sidewalk

- No shoulder on road or any other bicyclist facility
- Extensive parallel parking of motor vehicles
- Road surface is irregular with drains and grates in bicyclists' way
- Utility covers not flush with road surface
- Cause of all reported accidents was motorist inattention to bicyclists
- Large turning radius allows cars to turn corner at high speed
- Heavy motor vehicle traffic
- Poor drainage that traps water on roadway or at intersection
- Extensive commercial activity

- Influence of elevated subway accesses, bus stops and the medical center
- Heavy congestion, significant pedestrian activity, a multitude of commercial businesses and related signing
- Overabundance of regulatory and warning signing and pavement marking impede motorists' ability to safely navigate intersection
- Motorists' inattention to bicyclists and pedestrians resulted in numerous accidents

- Remove obstructions in sidewalk or keep obstructions near the curb in a confined space.
- Reduce area speed limit to allow all vehicles to more safely negotiate through the confusing and heavily regulated intersection.
- Install raised/textured “ladder style” crosswalks with reflectorized markings across all four legs of the intersection using high quality materials
- Install enforceable signing for pedestrians on each corner, as follows: WAIT FOR WALK SIGNAL
- Install enforceable signing for motorists as follows: NO TURN ON RED

- Installations of curb neckdowns to reduce right turn speed and lessen the street space to be crossed by a pedestrian.
- Installation of curb ramps at corners.
- Repave roadway surface, fixing drainage problem.
- Bring utility covers and grates flush with the road surface, or move out of direct bicycle path.
- Install bicycle lanes and intersection controls.

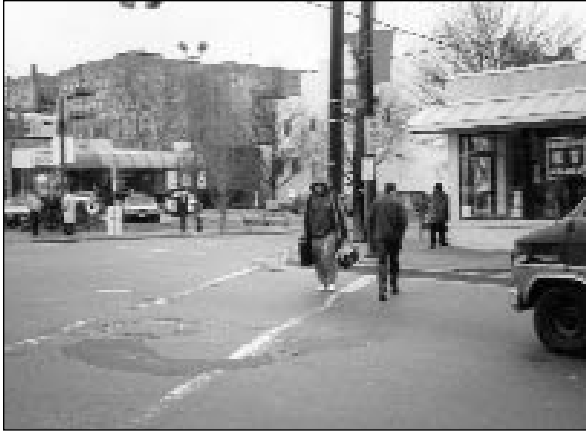
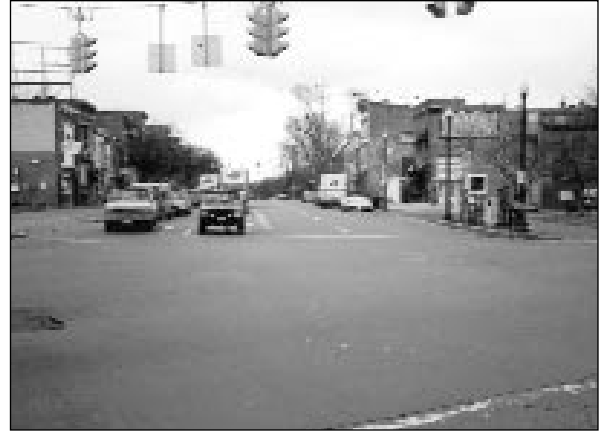
The Madison Avenue intersection with Delaware Avenue and Lark Street, located in a commercial area of the City of Albany, experiences heavy peak hour traffic of nearly 2,000 vehicles. Pedestrian traffic is significant during peak times, and even at off peak hours. A two-phased fixed time traffic signal controls the intersection traffic. There are no pedestrian signals. From September 1994 to August 1999, 95 crashes were reported at this intersection, including three pedestrian and one bicyclist crash.

- Multi-leg intersection with heavy turning traffic.
- On west side of intersection, long crosswalk across Madison Avenue have no pedestrian refuge.
- On southeast side of intersection, long crosswalk across Lark Street/Delaware Avenue.
- There are no pedestrian signals to guide and control safe pedestrian crossings.
- The crosswalks are minimally visible to approaching motorists.

- No specific provisions for bicyclists.
- Heavy volumes of turning traffic through the complex intersection.

- Complex multi-leg intersection geometry.
- Heavy through and turning vehicular traffic volumes.
- Significant pedestrian traffic.
- Minimally visible crosswalks.

- Relocate the crosswalk across the southerly leg of the intersection to provide a safe crossing between the southwest corner of the intersection of Madison and Lark to the southeast corner of Delaware and Madison, and to shorten the pedestrian waiting time in the intersection.
- Install “ladder style” crosswalks across all four legs of the intersection to increase their visibility to the motorists. Use high quality permanent materials for all pavement markings.
- Adjust traffic signal head for eastbound Madison Avenue traffic.
- Install pedestrian signals on each of the four corners.

- Channelize, with pavement markings, the west side Madison Avenue approach to provide a pedestrian refuge and to better direct 1) eastbound traffic into the narrower Madison Avenue east of the intersection and 2) left-turning vehicles into northbound Lark Street.
- Install pavement markings and new turning arrows.
- Stripe, with pavement markings, a bullnose to channelize and guide eastbound right turning traffic from Madison into Delaware and to delineate a parking bay on the east side of Lark Street south of the intersection.
- Install bicycle lanes and intersection controls.

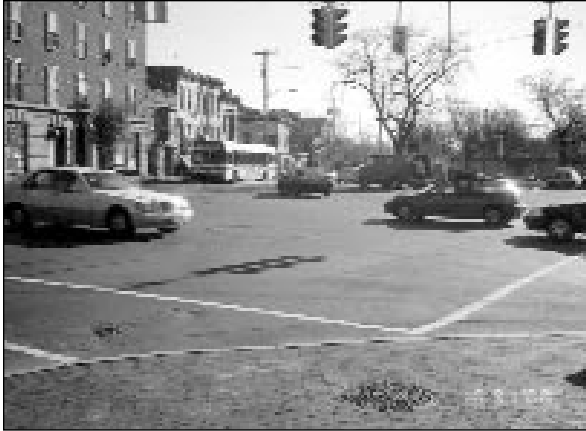
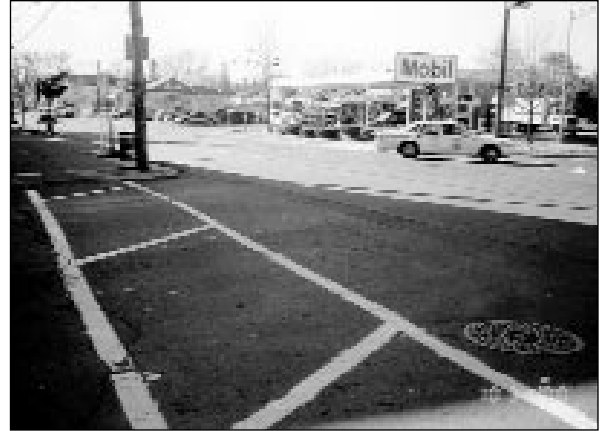
The Delaware Avenue intersection with Whitehall Road, Second Avenue and Ten Eyck Avenue is located in a commercial area on the south edge of the City of Albany. This intersection experiences heavy through and turning traffic volumes. A nearby senior center, nursing homes and a park contribute to special crossing needs. A three-phase traffic signal controls the intersection. Fixed time pedestrian signals only on three corners. From September 1994 to August 1999, 61 crashes, including three pedestrian crashes, were reported at this intersection.

- Heavy left and right turn movements between northbound Delaware and eastbound Whitehall across crosswalk on west side of intersection, especially during peak hours of traffic flow.
- Heavy eastbound and westbound peak hour traffic flow between Whitehall and Second Avenue.
- No pedestrian signal on southwest corner of Delaware and Second Avenue.
- Traffic from Delaware and Second Avenue splits without guidance or control into Whitehall and Ten Eyck Avenue.
- No channelization to guide traffic or pedestrians in the open area between Whitehall and Ten Eyck.

- No specific provisions for bicyclists.
- Complex intersection geometry and heavy through and turning traffic volumes.
- Three phase traffic signal operation.
- Busy driveways into Mobil station in the southeast quadrant of the intersection.

- Awkward and difficult intersection geometry.
- Heavy peak hour traffic volumes.
- Minimally visible crosswalks.
- No pedestrian signal in southeast quadrant, thus no pedestrian guidance or control.
- No stop line at any approach to the intersection.

- Install pedestrian actuated signal on southwest corner of Delaware Avenue and Second Avenue.
- Install "ladder style" crosswalks across each approach to the intersection, using high quality, permanent, reflective pavement marking materials.
- Install stop lines on each approach, using high quality, permanent, reflective pavement marking materials.
- Install painted bullnose channelization between Whitehall Road and Ten Eyck Avenue, using high quality, permanent, reflective pavement marking materials.

- Install bicycle lanes and intersection controls.

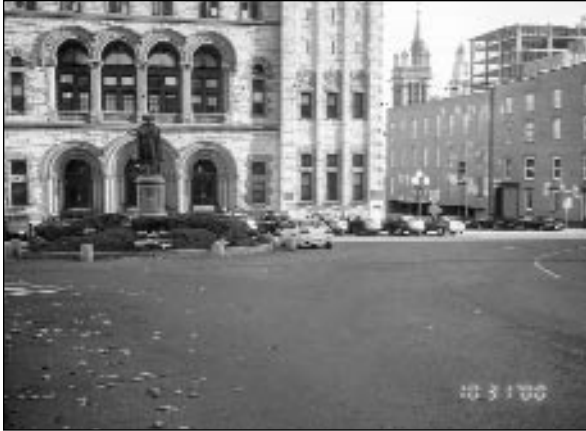
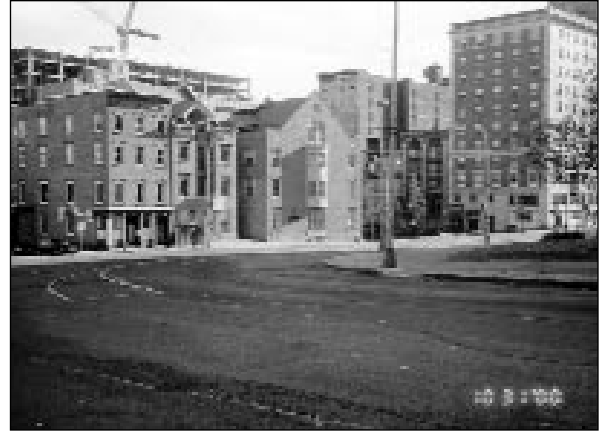
The intersection of Washington Avenue with Eagle Street, Pine Street and Maiden Lane in Albany's Central Business District presents a difficult intersection for motorists and is daunting to pedestrians and bicyclists. Washington Avenue is considered a minor arterial. Eagle Street and Pine Street are collectors and Maiden Lane is a local road. The project area is the busiest bus route on Washington Avenue. There are two handicap accessible ramps, one on the corner of the State Capitol and the other on the corner of the park across from the northeast corner of City Hall, but no crosswalks. There are no provisions for bicyclists. In the past five years, there have been six accidents, including 1 involving a pedestrian.

- No crosswalks
- Two handicap accessible ramps that dump pedestrians, physically impaired or otherwise, into the travel way
- Obstructions in sidewalk
- Pedestrians must cross substantive distances of unmarked pavement

- Scarcity of pavement markings makes it unclear how best to navigate through the intersection
- Lack of crosswalks and other pedestrian amenities indicates a de-emphasis of the pedestrian and bicyclist environment.

- Install a curb cut on the north side of Washington Avenue by eliminating one parallel parking place.
- Install a raised and textured band around the monument of three foot width beyond concrete posts.
- Install raised and textured band around the monument of three foot width beyond concrete posts
- Install YIELD TO PEDESTRIANS signs, as shown
- Install bicycle lanes and intersection controls.

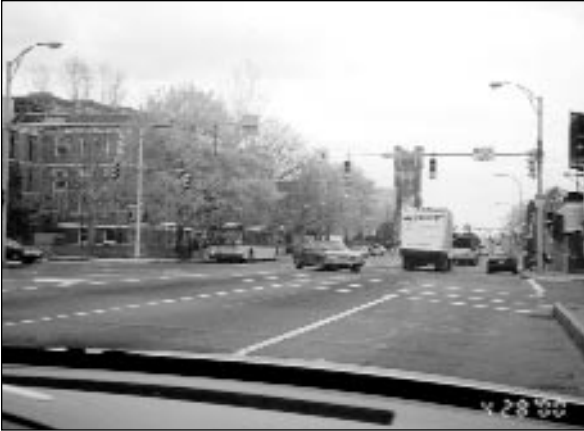
Dense commercial activity and a heavy volume of automobiles, trucks and transit buses, as well as pedestrians and bicyclists competing for the same space. Driver inattention and failure to yield the right of way are compounded by pedestrian jaywalking and crossing against the signal. A de-emphasis of the pedestrian environment within the Central Business District sends the wrong message to motorists.

- Bus stops, in combination with other features of an urban central business district, have potential to obstruct view.
- Poorly defined crosswalks do not capture the motorists' attention.

- Determine if pedestrian signal is warranted to cross Alexander St.
- Reduce turning radii to reduce the speed of turning cars.
- Repave roadway, bringing the grates flush with the road surface.
- Install shoulder.
- Install bicycle lanes and intersection controls.

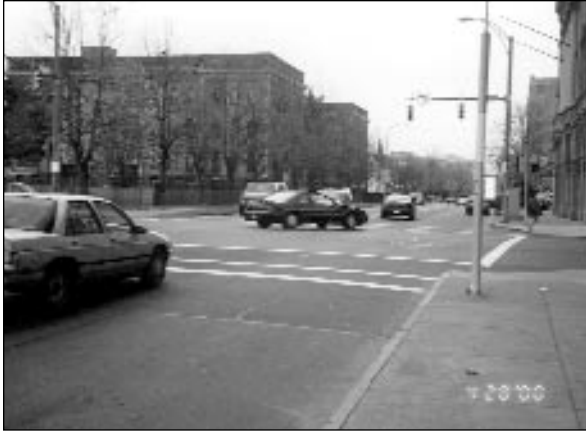
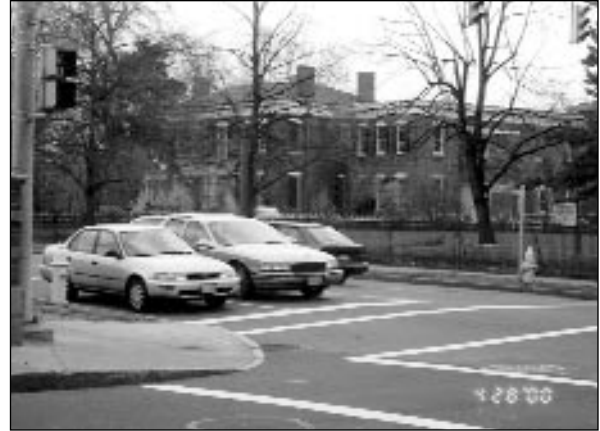
Dense commercial activity, and a heavy volume of automobiles, trucks and transit buses, as well as pedestrians and bicyclists are competing for the same space. Driver inattention and failure to yield the right of way are evident as the cause of reported crashes. A de-emphasis of the pedestrian environment within the Central Business District sends the wrong message to motorists.

- Poorly defined crosswalks and a lack of bicycling facilities. Motorists are not alerted to pedestrian and bicyclist presence.

- Repave roadway, paying attention to bring the grates flush with the road surface.
- Reduce turning radii to slow the speed of turning cars.
- Install bicycle lanes and intersection controls.

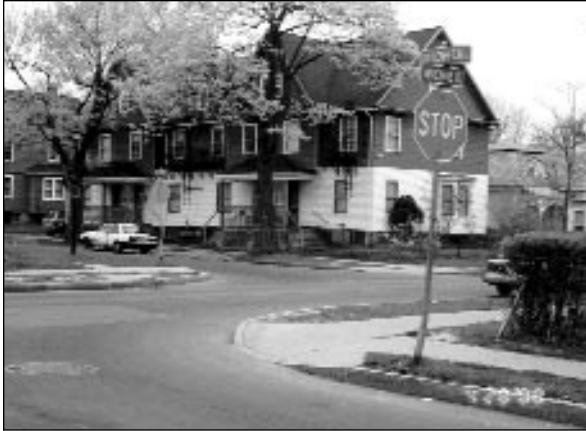
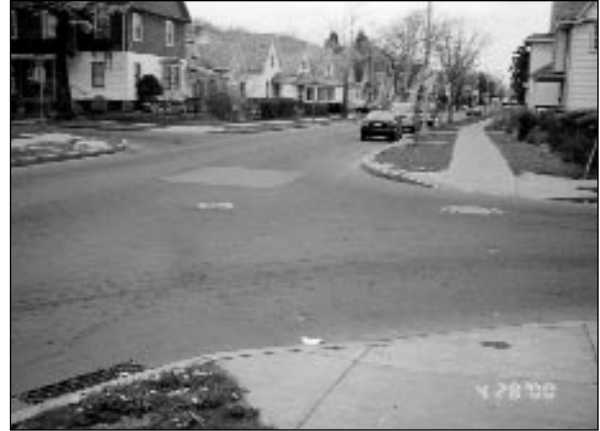
- No specific provisions for bicyclists.
- Bicyclists ride on the sidewalks.
- Inadequate sight distance for bicyclists and motorists in the northwest corner of Hollenbeck Street and Avenue D.

- No pavement markings.
- No centerline striping on Avenue D or Hollenbeck Street.
- No stop lines on Hollenbeck Street at Avenue D.
- No crosswalk across Avenue D.
- No crosswalks across Hollenbeck Street at Avenue D.
- Dog leg intersection for through traffic on Hollenbeck Street crossing Avenue D.
- No advance warning of pedestrians crossing Avenue D.
- Limited sight distance for southbound Hollenbeck Street traffic approaching Avenue D.

- Open the sight distance triangle on the northwest corner of Hollenbeck Street and Avenue D.
- Install bicycle lanes and intersection controls.

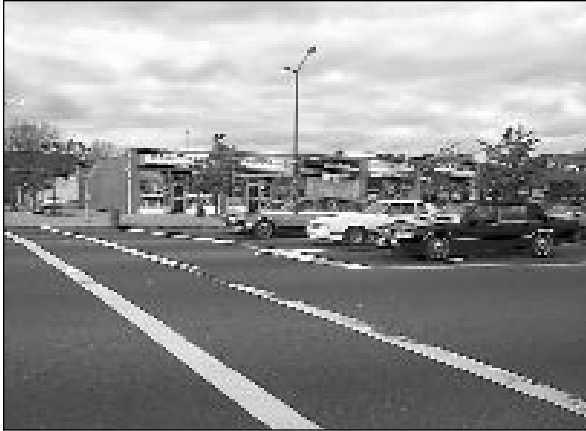
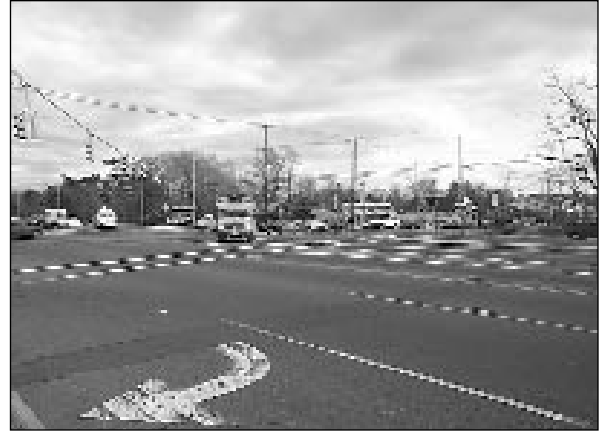
- Lack of shoulder on Carleton Avenue and narrow shoulders on Suffolk Avenue.
- Motorists' failure to yield right of way to bicyclists resulted in two of the three reported crashes.
- Turning radius is large with dedicated turn lanes, allowing cars to make high speed turns.
- Heavy motor vehicle traffic.
- Railroad tracks cross Carleton Avenue.

- Intense commercial area.
- Heavy traffic volumes.
- Poorly defined crosswalks.
- Railroad tracks cross Carleton Avenue.
- Central Islip railroad station less than half mile away.

- Consider in-pavement pedestrian lights to warn right-turning drivers of pedestrian phase activation.
- Install curb cuts for crosswalks.
- Install neckdowns that offer traffic calming features and reduce crossing distance for pedestrians while maintaining five ft. width for bicycle lane.
- Install pedestrian countdown timers.
- Consider reconstruction of radii to eliminate free flow right turn lane.
- Install bicycle lanes and intersection controls.

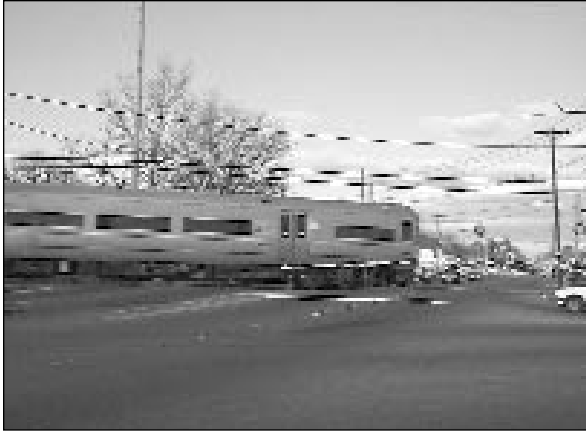
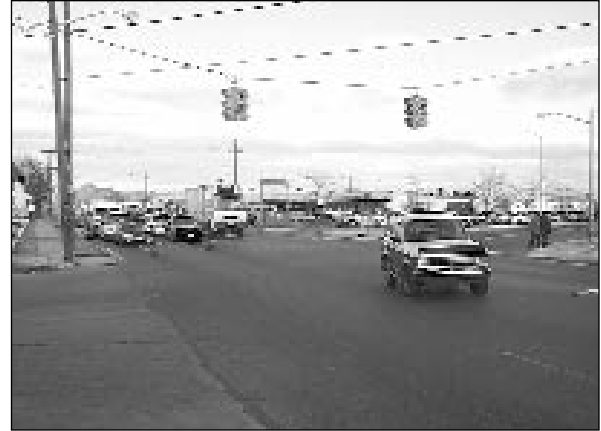
- Railroad crossing.
- Proximity of Wyandanch railroad station.

- Change from four lanes on Straight Path to three-lane section with shoulders and center two-way left turn lane (subject to a detailed intersection analysis).
- Exclusive turn lanes between Long Island Avenue and Acorn Street.
- Consider installation of bulbouts that offer traffic calming features and reduce crossing distance for pedestrians.
- Install bicycle lanes and intersection controls.

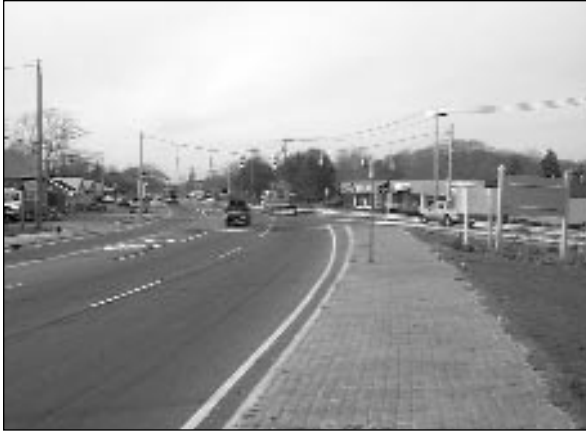
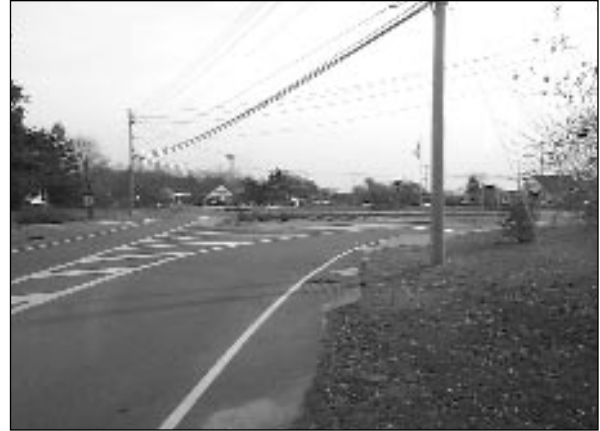
- Pedestrians and bicyclists cross unexpectedly, and have the potential to surprise motorists along this merge of two county highways in a relatively rural, bucolic area.

- Construct curb cuts at all existing and proposed crosswalk locations.
- Add speed tables or humps, as shown.
- Install bicycle lanes and intersection controls.
